**Flood Control Project Maintenance
Levee Inspections**

Maintenance Issue Types Only, Levee Inspection Report By Mile - Fall 2014

Reclamation District No. 0536 Egbert

Waterway	Bank	Unit Miles	Inspection Start/End	Inspector
Unit No. 01 Lindsey Slough	Right	5.58	11/05/2014 11/05/2014	Herman Phillips

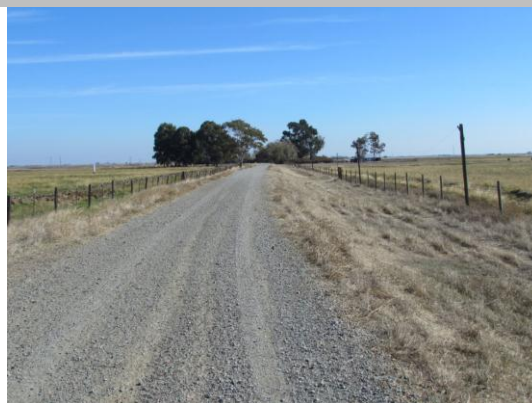
Photo 1 of 1 : FA_2014_RD0536_208_24_20141107_00016.jpg

LM Start	0.03	Rating **	A/W	Issue No.	24
LM End	1.78	Issue Type +	Ma	Location *	LS
Category	Earthen Levee			GPS Latitude/Longitude	
				Start	End
Item	Vegetation			38.245012 °	38.259667 °
				-121.768460 °	-121.749812 °
DWR ID	DWR_RD0536_01_f_2014_24				
Action/Comments					
Control annual grass and weeds on the levee slopes and easements. Inspector Comments: At this location there is no problem with the vegetation.

Looking downstream from levee mile 0.02 landside slope.

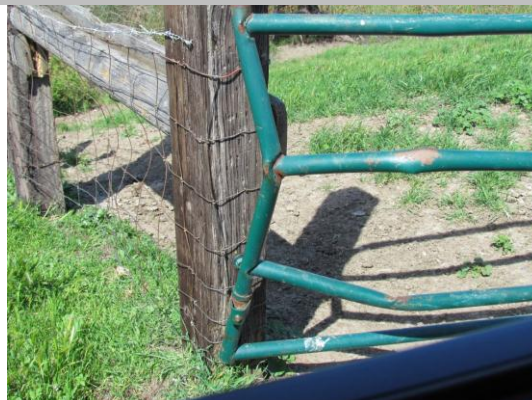
Photo 1 of 1 : FA_2014_RD0536_208_25_20141030_00002.jpg

LM Start	1.10	Rating **	U	Issue No.	25
LM End	1.10	Issue Type +	Ma	Location *	CR
Category	Earthen Levee			GPS Latitude/Longitude	
				Start	End
Item	Repair Gates			38.255455 °	38.255455 °
				-121.757587 °	-121.757587 °
DWR ID	DWR_RD0536_01_s_2014_25				
Action/Comments					
Inspector Comments: This gate looks like its been run over, the bottom hinge is broken thus making the gate hard to open and close properly.

This gate needs to be replaced.

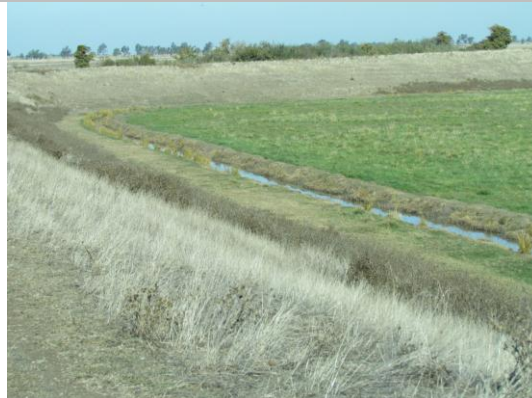
Photo 1 of 1 : FA_2014_RD0536_208_43_20141107_00018.jpg

LM Start	1.19	Rating **	U	Issue No.	43
LM End	1.32	Issue Type +	Ma	Location *	LS
Category	Earthen Levee			GPS Latitude/Longitude	
				Start	End
Item	Vegetation			38.256722 °	38.258655 °
				-121.757558 °	-121.757393 °
DWR ID	DWR_RD0536_01_f_2014_43				
Action/Comments					
Remove the wild growth other than native grasses from the levee slopes.					
Inspector Comments: Remove the tall weeds from the landward levee slope.

Tall weeds on landside slope and toe of levee section.

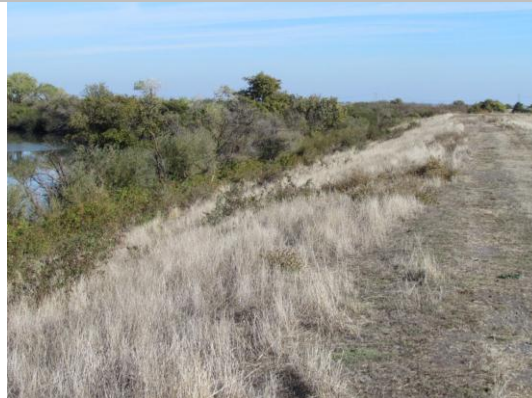
Photo 1 of 1 : FA_2014_RD0536_208_45_20141107_00019.jpg

LM Start	1.34	Rating **	U	Issue No.	45
LM End	4.31	Issue Type +	Ma	Location *	WS
Category	Earthen Levee			GPS Latitude/Longitude	
				Start	End
Item	Vegetation			38.258860 °	38.248497 °
				-121.757142 °	-121.717193 °
DWR ID	DWR_RD0536_01_f_2014_45				
Action/Comments					
Remove the wild growth other than native grasses from the levee slopes.					
Inspector Comments: Unwanted wild growth of weeds and wild roses growing on the waterward levee slope.

Wild growth of wild roses present on waterside slope and toe.

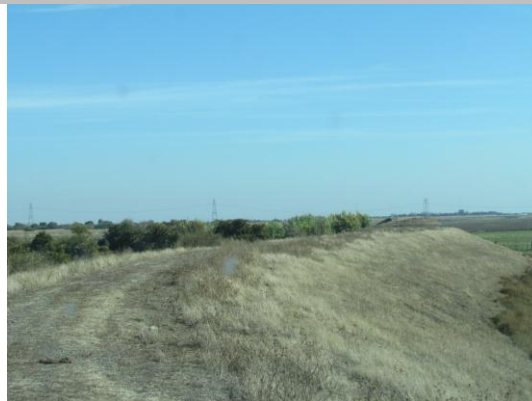
Photo 1 of 1 : FA_2014_RD0536_208_48_20141107_00020.jpg

LM Start	1.42	Rating **	U	Issue No.	48
LM End	1.52	Issue Type +	Ma	Location *	LS
Category	Earthen Levee			GPS Latitude/Longitude	
				Start	End
Item	Vegetation			38.259203 °	38.258757 °
				-121.755698 °	-121.753883 °
DWR ID	DWR_RD0536_01_f_2014_48				
Action/Comments					
Remove the wild growth other than native grasses from the levee slopes.					
Inspector Comments: The landward levee slope is covered in wild weeds and star thistle.

Unwanted star thistle on shoulder landward downstream to levee mile 1.52

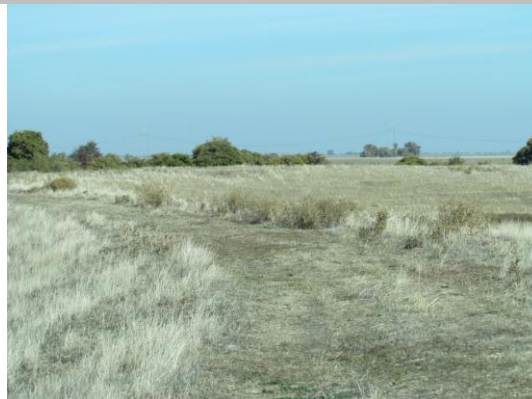
Photo 1 of 1 : FA_2014_RD0536_208_49_20141107_00021.jpg

LM Start	1.59	Rating **	U	Issue No.	49
LM End	1.74	Issue Type +	Ma	Location *	CR
Category	Earthen Levee			GPS Latitude/Longitude	
				Start	End
Item	Vegetation			38.258792 °	38.259777 °
				-121.752675 °	-121.750418 °
DWR ID	DWR_RD0536_01_f_2014_49				
Action/Comments					
Keep the crown roadway free of vegetation.					
Inspector Comments: Crown roadway should be kept free of vegetation.

Unwanted grasses present on crown roadway.

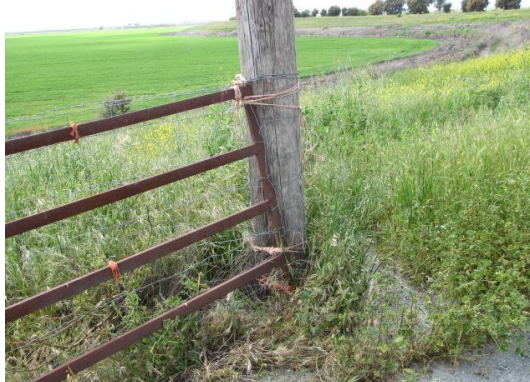
Photo 1 of 1 : FA_2014_RD0536_208_36_20141030_00004.jpg

LM Start	3.68	Rating **	U	Issue No.	36
LM End	3.68	Issue Type +	Ma	Location *	WS
Category	Earthen Levee			GPS Latitude/Longitude	
				Start	End
Item	Repair Gates			38.252578 °	38.252578 °
				-121.726439 °	-121.726439 °
DWR ID	DWR_RD0536_01_s_2012_36				
Action/Comments					
Inspector Comments: This gate need to be repaired.

Repair this gate. Someone could get hurt trying to open and close this gate. No new picture was taken, no change to this gate. 09-04-2014.

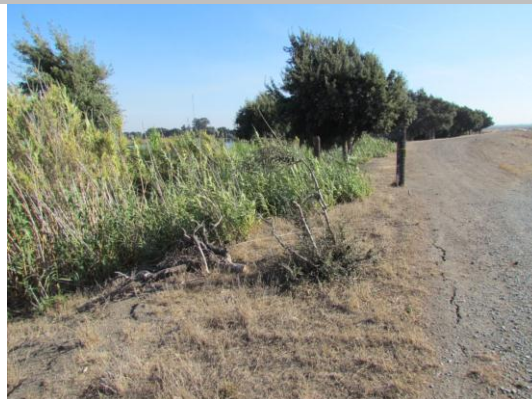
Photo 1 of 1 : FA_2014_RD0536_208_69_20141107_00027.jpg

LM Start	4.63	Rating **	U	Issue No.	69
LM End	4.65	Issue Type +	Ma	Location *	WS
Category	Earthen Levee			GPS Latitude/Longitude	
				Start	End
Item	Vegetation			38.248297 °	38.248002 °
				-121.712055 °	-121.711892 °
DWR ID	DWR_RD0536_01_f_2014_69				
Action/Comments					
Remove the wild growth other than native grasses from the levee slopes.					
Inspector Comments: Remove the wild Arundo from the waterward levee slope.

Unsatisfactory growth of Arundo present on waterward levee section.

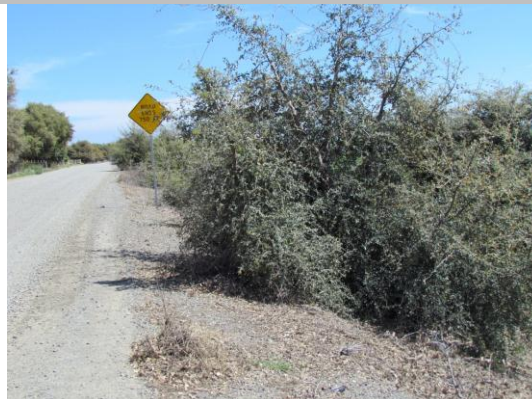
Photo 1 of 1 : FA_2014_RD0536_208_65_20141030_00007.jpg

LM Start	5.17	Rating **	U	Issue No.	65
LM End	5.31	Issue Type +	Ma	Location *	LS
Category	Earthen Levee			GPS Latitude/Longitude	
				Start	End
Item	Vegetation			38.245300 °	38.245653 °
				-121.704909 °	-121.702569 °
DWR ID	DWR_RD0536_01_s_2014_65				
Action/Comments					
Trees / Woody Vegetation					
Inspector Comments: These young oak trees need to be removed from the landward slope and shoulder before they get any larger.

Looking downstream from levee mile 5.17 to 5.31 at unsatisfactory woody tree growth on landside levee slope and shoulder.

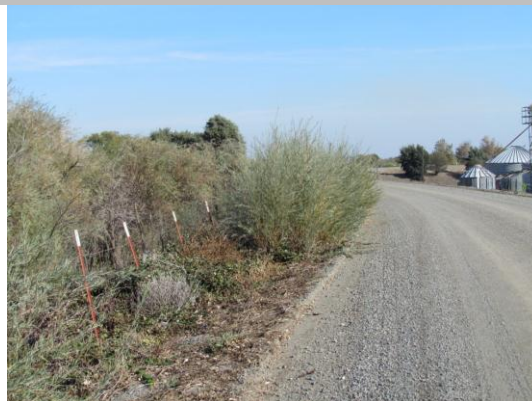
Photo 1 of 1 : FA_2014_RD0536_208_70_20141107_00028.jpg

LM Start	5.46	Rating **	U	Issue No.	70
LM End	5.58	Issue Type +	Ma	Location *	WS
Category	Earthen Levee			GPS Latitude/Longitude	
				Start	End
Item	Vegetation			38.245608 °	38.245610 °
				-121.699768 °	-121.697493 °
DWR ID	DWR_RD0536_01_f_2014_70				
Action/Comments					
Remove the wild growth other than native grasses from the levee slopes.					
Inspector Comments: District need to remove the wild growth from the waterward levee slope and shoulder.

Unsatisfactory growth of young trees present on waterside levee shoulder and slope.

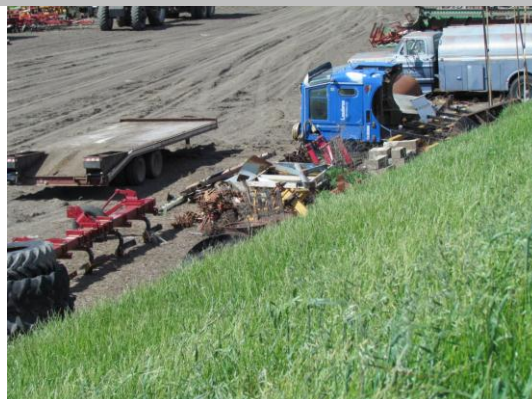
Photo 1 of 1 : FA_2014_RD0536_209_5_20141008_00001.jpg

LM Start	0.01	Rating **	M	Issue No.	5
LM End	0.06	Issue Type +	Ma	Location *	LS
Category	Earthen Levee			GPS Latitude/Longitude	
				Start	End
Item	Encroachments			38.244240 °	38.243630 °
				-121.696830 °	-121.696470 °
DWR ID	DWR_RD0536_02_s_2012_5				
Action/Comments					
Equipment					
Inspector Comments: Equipment within the 10-foot easement looking from levee mile 0.06 back towards 0.01.

Unauthorized encroachment on the landward side within 10-foot of the levee toe, looking back upstream. No new picture, no change with this issue.

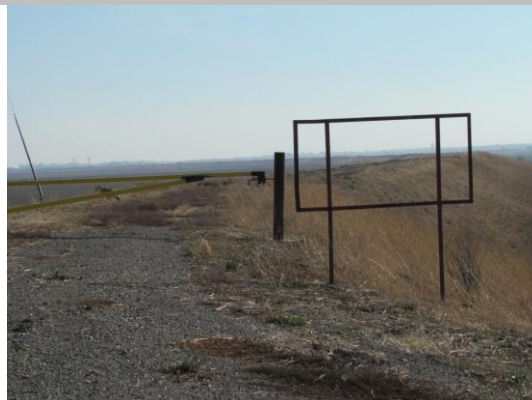
Photo 1 of 1 : FA_2014_RD0536_209_17_20141112_00009.jpg

LM Start	0.02	Rating **	U	Issue No.	17
LM End	0.02	Issue Type +	Ma	Location *	LS
Category	Earthen Levee			GPS Latitude/Longitude	
				Start	End
Item	Vegetation			38.244225 °	38.244225 °
				-121.696980 °	-121.696980 °
DWR ID	DWR_RD0536_02_s_2014_17				
Action/Comments					
Remove the wild growth other than native grasses from the levee slopes.					
Inspector Comments: Remove the tall weeds present at the gate landside of levee.

Tall weeds present at gate on the landside slope.

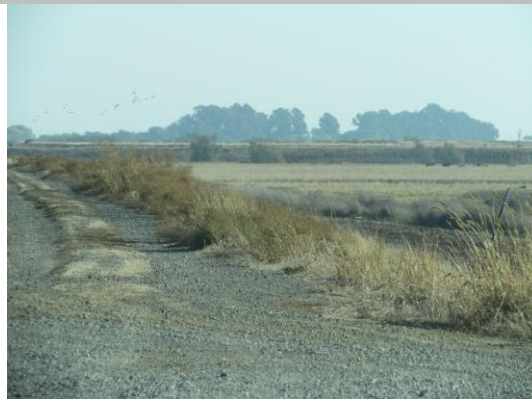
Photo 1 of 1 : FA_2014_RD0536_209_12_20141112_00013.jpg

LM Start	2.53	Rating **	U	Issue No.	12
LM End	4.34	Issue Type +	Ma	Location *	LS
Category	Earthen Levee			GPS Latitude/Longitude	
				Start	End
Item	Vegetation			38.208848 °	38.196775 °
				-121.691115 °	-121.699223 °
DWR ID	DWR_RD0536_02_f_2014_12				
Action/Comments					
Control annual grass and weeds on the levee slopes and easements. Inspector Comments: Dead weeds present on the landward slope need to be removed.

Dead tall weeds present on the landward slope.

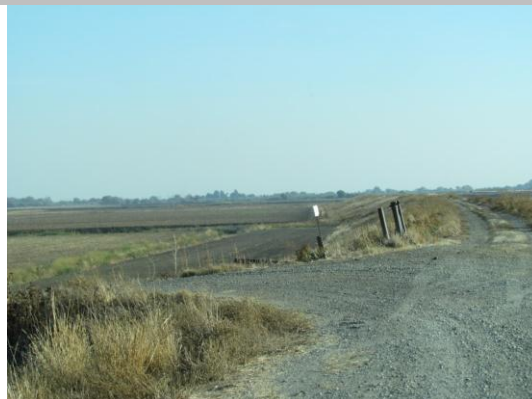
Photo 1 of 1 : FA_2014_RD0536_209_13_20141112_00012.jpg

LM Start	2.53	Rating **	U	Issue No.	13
LM End	4.34	Issue Type +	Ma	Location *	WS
Category	Earthen Levee			GPS Latitude/Longitude	
				Start	End
Item	Vegetation			38.208848 °	38.196775 °
				-121.691115 °	-121.699223 °
DWR ID	DWR_RD0536_02_f_2014_13				
Action/Comments					
Control annual grass and weeds on the levee slopes and easements. Inspector Comments: Control the tall weeds from the levee section waterward.

Unwanted tall weeds present on the waterward levee slope.
